CIVIL AERONAUTICS BOARD

ACCIDENT INVESTIGATION REPORT

NORTHWEST AIRLINES, INC.—WINONA, MINNESOTA—AUGUST 29, 1948

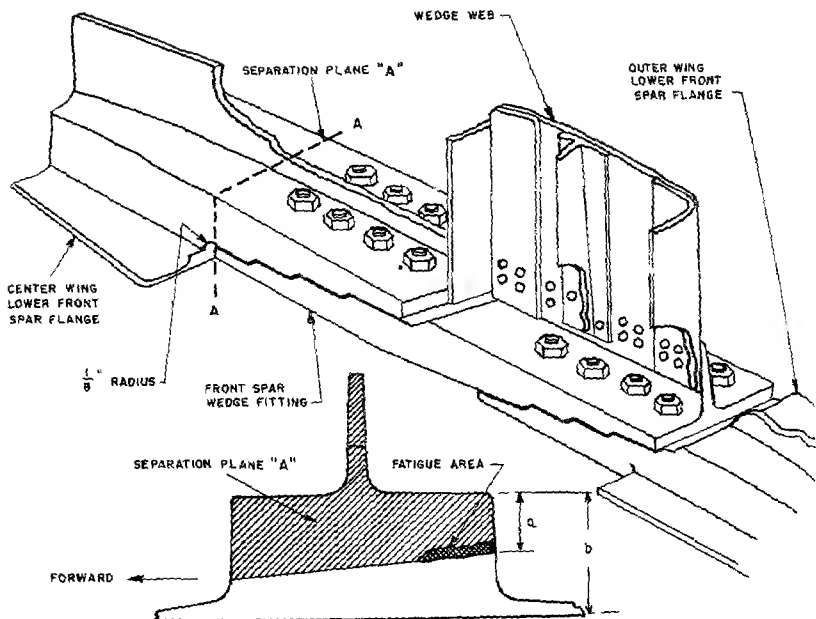
WING ROOT FITTING

The outer wing front and rear lower spar flanges attach to the center wing front and rear lower spar flanges by means of a dihedral wedge as illustrated in the attached drawing. Originally, the spar flanges were bolted directly together, but tests of the prototype airplane demonstrated a need for a greater lateral stability. Therefore, the outer wing was rotated seven degrees upward by means of incorporating the dihedral wedge in the attachment of the outer wing to the center section. It will be noted in the drawing of this part that the attachment ends of the lower spar flanges and dihedral wedge have four steps or vertical increases in thickness. In each step the vertical increase in thickness is approximately 13/64 of an inch, except for the fourth step inboard on the center section spar flange where the vertical increase in the thickness is approximately 3/4 of an inch. The radius in the fillet of these steps is approximately 1/8 of an inch.

Evidence indicated that the outer wing had first separated from the center section in the fillet of the fourth step of the lower front center section spar flange. Examination of this fracture revealed that the separation had started from a fatigue crack approximately 7/8 of an inch long, and 3/32 of an inch deep, the remaining cross section of the material at this point failing from tension.

The particular design of the connection of the lower flange for the front spar of the outer panel to the center panel for the Martin 202 is indicative to high local stress concentration. Hence, it is readily susceptible to fatigue. These high local stress concentrations are due to the following characteristics: the fitting contained fillets of a small radius in the step down of 1/8 inch, there was a large sudden change in cross section in the fourth step down inboard from the attachment, increasing the depth to approximately twice its thickness, and the cross sectional area was designed to a high percentage of the ultimate strength of the material.

6. The fillet of the fourth step inboard of the lower left front center section spar flange revealed a fatigue fracture approximately 7/8 of an inch long and 3/32 of an inch deep. The remaining area failed in tension.

SCHEMATIC SECTION OF SEPARATION OF LOWER FLANGE SHOWING FATIGUE AREA AND ALSO
SUDDEN INCREASE OF DEPTH OF FLANGE "a" TO APPROXIMATELY TWICE THE DEPTH AS INDICATED BY "b"

At the present time the wing root fittings on the Martin 202s are being given frequent and thorough inspections for the development of fatigue cracks, and the operating speeds have been reduced ten percent. In addition, the front center section spar flange has been modified so as to include five steps or vertical increases in thickness to avoid any radical change in cross section. The radius in the fifth step fillet has been increased from 1/8 of an inch to 3/4 of an inch; two bolts have been added, and all parts have been polished. In general the above constitutes present corrective action approved by the Administrator of Civil Aeronautics. It is considered to be temporary in nature, but sufficient for safe operation until 3,000 hours of flight. After 3,000 hours of flight have been accumulated on the aircraft or before, the airplane will be modified at the Martin Company with a permanent correction which involves extensive structural changes to the wing.
